DEEP-OCEAN BIODETERIORATION
OF MATERIALS — PART VI. ONE
YEAR AT 2,370 FEET

May 1967

U. S. NAVAL CIVIL ENGINEERING LABORATORY
Port Hueneme, California

Technical Report R-525

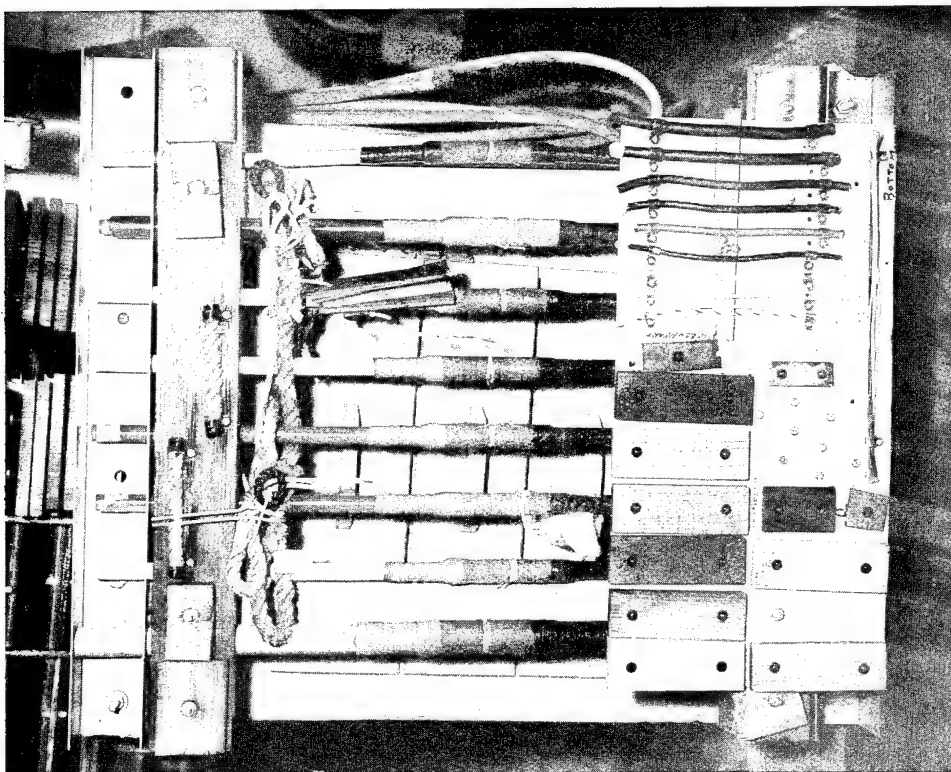
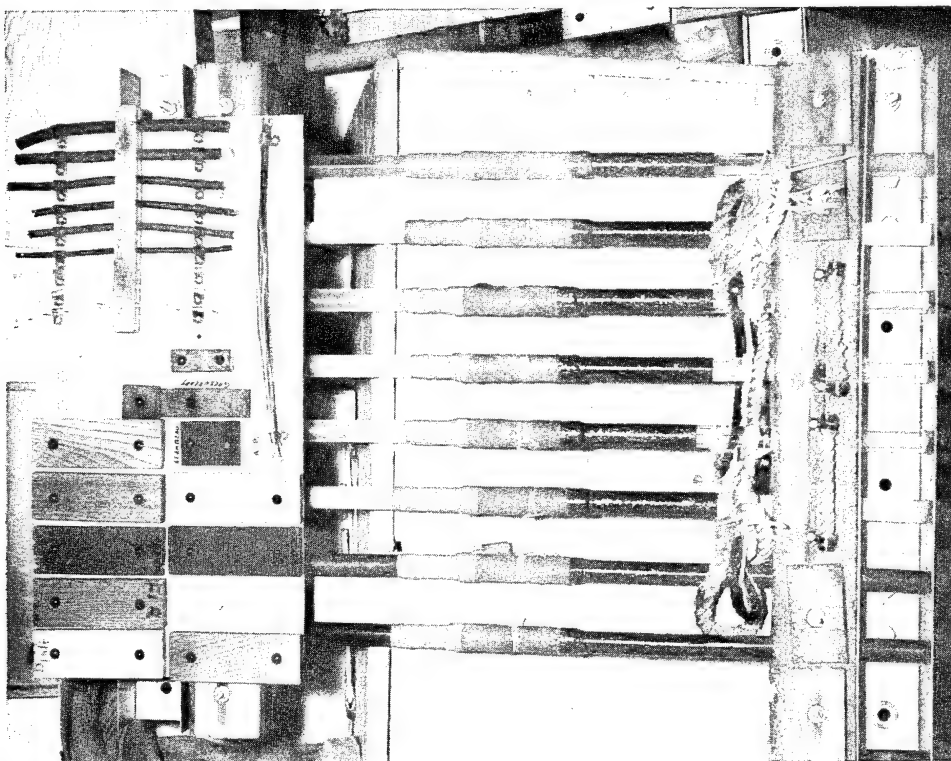
Figure 6. Bio-racks immediately after recovery from the sea. Compare with Figure 3.

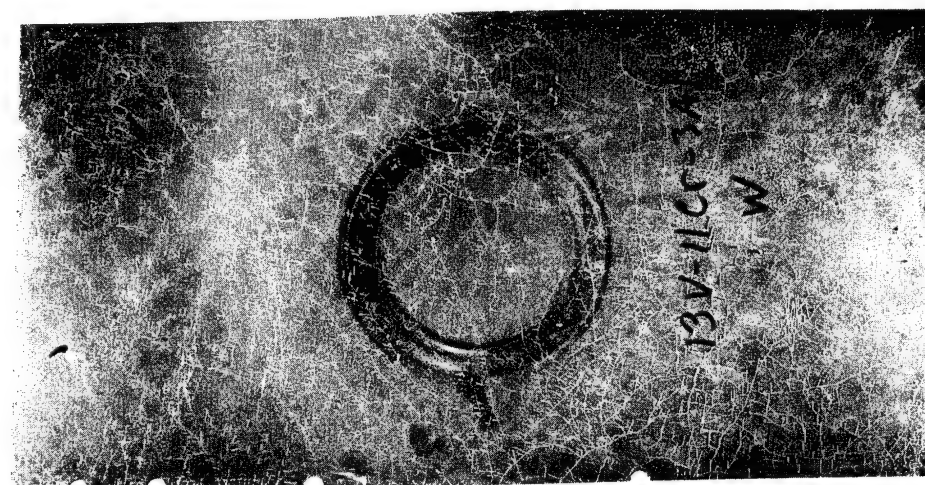
Figure 8. Hydroid growth on titanium test panel.

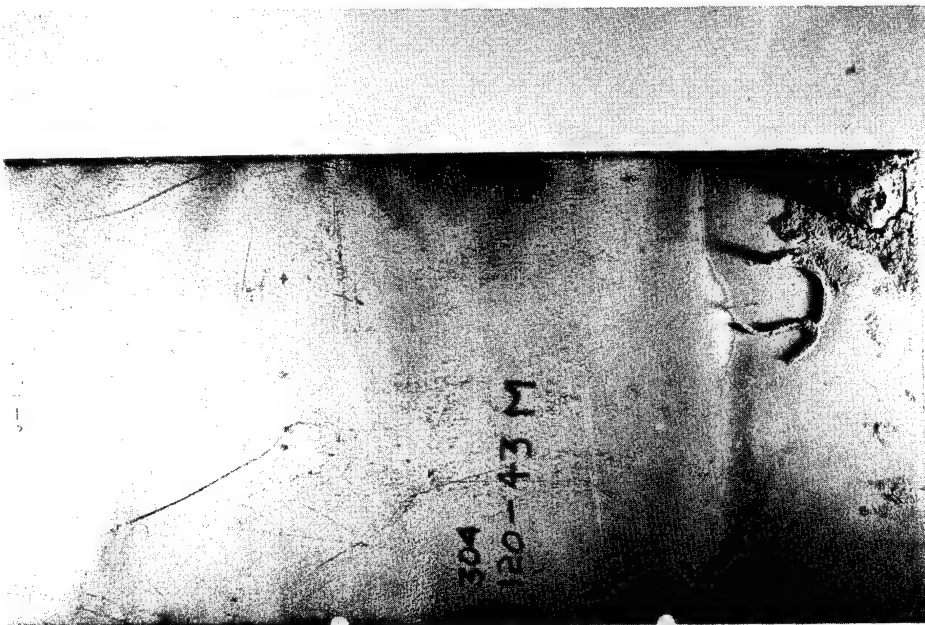
Several tubeworms (3-inch-long tubes made of mud and bottom debris) were found on stainless steel panels which were partially buried in the sediment (Figures 9 and 10). Another variety of tubeworms (tubes made of white calcareous materials) were found on stainless steel and titanium panels (Figure 11). A small pecten about 1/8 inch in diameter was also found attached to a titanium panel which was partially buried in the sediment (Figure 12). Several deep sea crabs (Figure 13), gastropods (Figure 14), and a large sea anemone (Figure 15) were found on various test panels.

Figure 9. Tubeworm on a bottom section of a stainless steel panel exposed in the sediment.

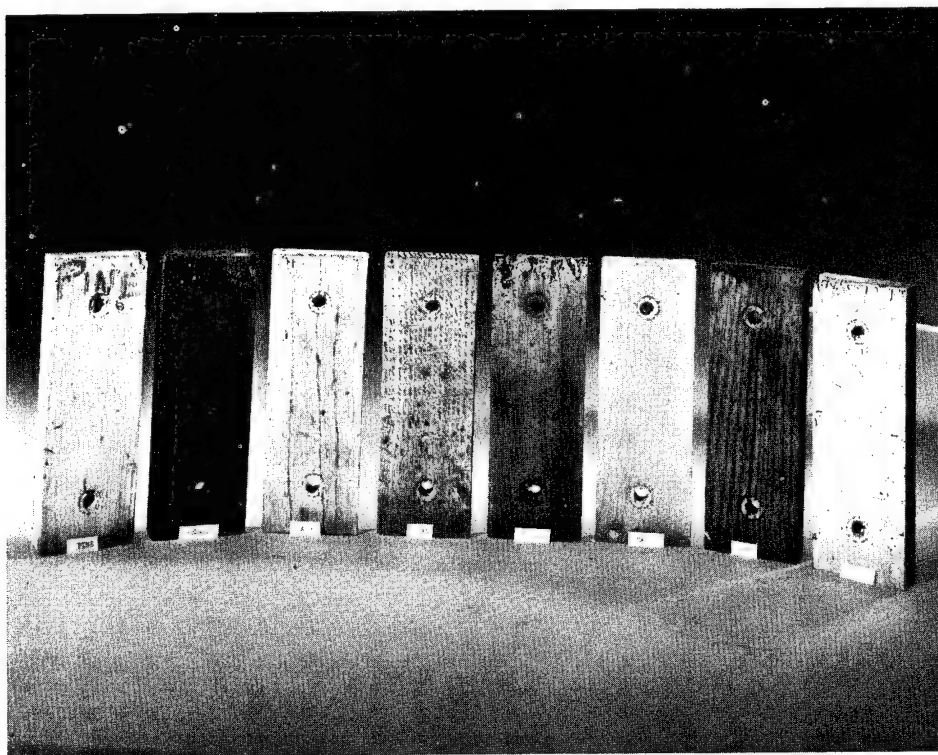
Wood Panels. Various kinds of untreated wood panels (1/2 x 2 x 6-inch) such as pine, fir, ash, maple, cedar, oak, and redwood were exposed to determine the effects of marine organisms on different woods. All the wood panels were attacked by marine borers and sustained light to heavy damage. Redwood and cedar were the most severely damaged; maple, pine, oak, and ash were moderately damaged; and fir sustained the lightest damage (Figures 16 & 17).

Figure 16. Various types of wood panels (exterior).

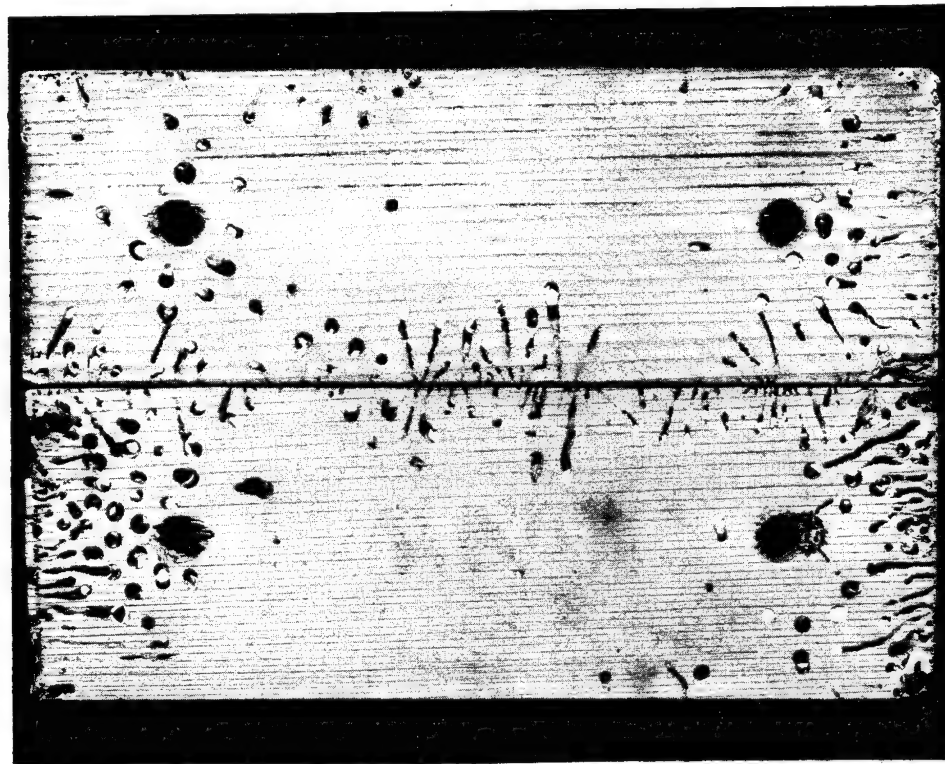
The diameter of the shells of the majority of the borers in these woods measured about 1/8 inch. Some borers in cedar and redwood had penetrated about 3/4 inch into the wood from the cut end of a panel (Figures 18 & 19). The loss in weight of each of these panels due to borer damage is presented in the Appendix.

Figure 18. Closeup view of interior side of cedar (l.) and redwood panels.

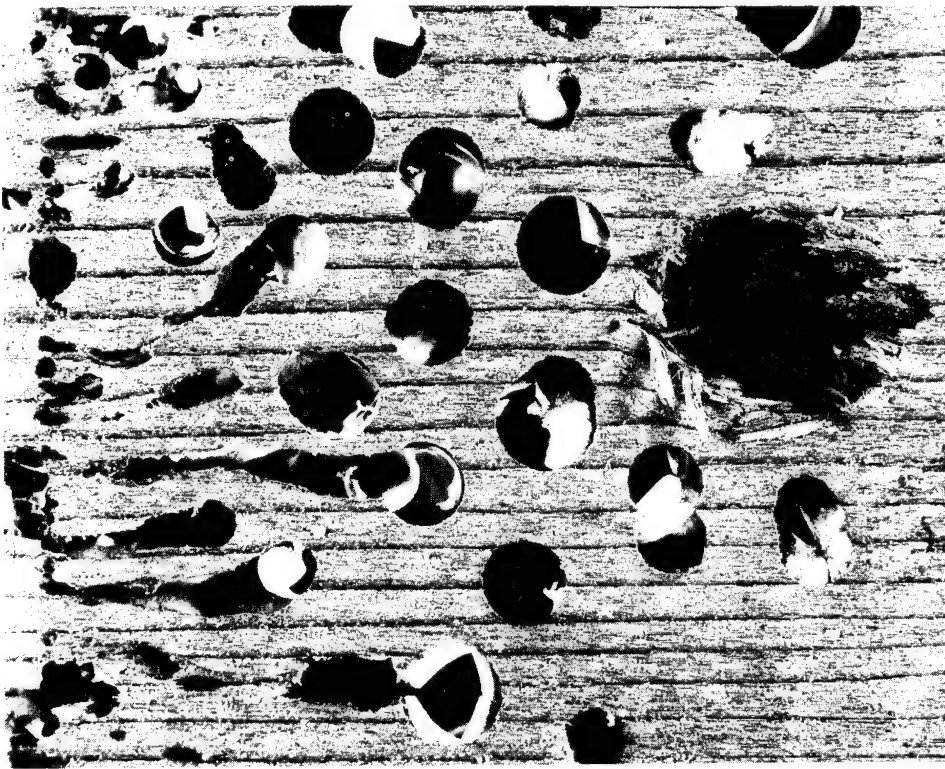
Figure 19. Closeup view of cedar panel showing 1/8-inch-diameter marine borers in holes.

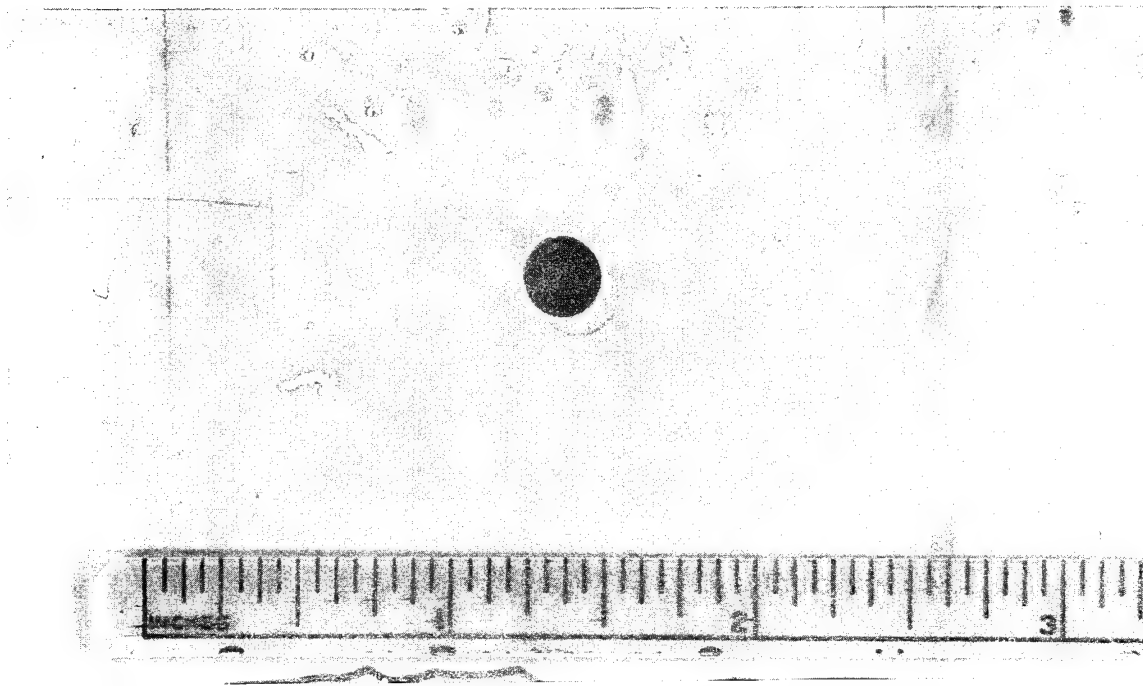
Figure 20. Phenolic laminated plastic sheet damaged by borers in an area which was in contact with wood. Compare size of damage to 1/4-inch-diameter bolt hole.

The surface of the phenolic laminated plastic sheet where the wood panels were attached was damaged by these borers (Figure 20). The borers had attacked the wood first and had then continued to bore into the plastic. Deep sea fungi were not found in any of the 1/2x2x6-inch panels which were exposed about 3 feet above the sediment layer. However, the surfaces of these wood panels were slightly deteriorated by bacterial action.

A phenolic resin plastic sheet (1/8x12x30 inches), onto which smaller test specimens were attached and then secured to the bio-racks, was damaged by borers. The damage was confined to the area where the wood panels were secured to the plastic sheet. The borers had attacked the wood first and had then continued to penetrate into the surface of the plastic sheet.

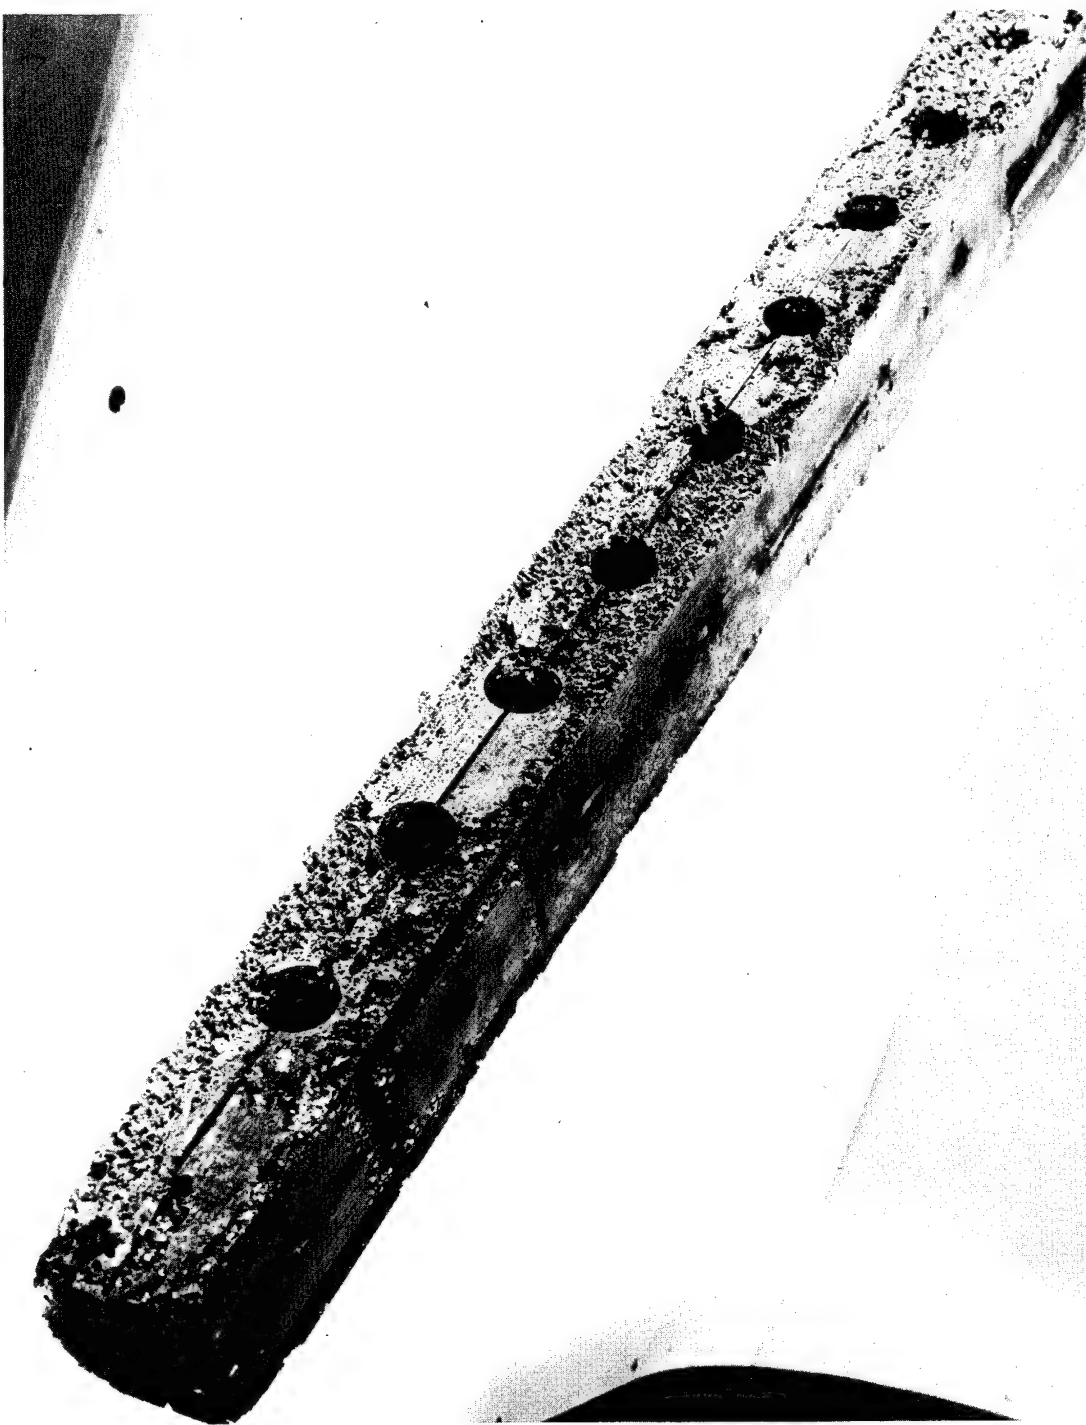
The 2x4x30-inch untreated fir bait pieces which were fitted over the plastic rods and tubes were deteriorated by borers. The heaviest damage was confined to the bottom side of a bait piece exposed right next to the sediment (Figures 21 & 22). Generally the large bait pieces were in fairly good condition, because the borers had not had time to penetrate deeply.

Figure 21. Untreated fir bait piece damaged by borers.

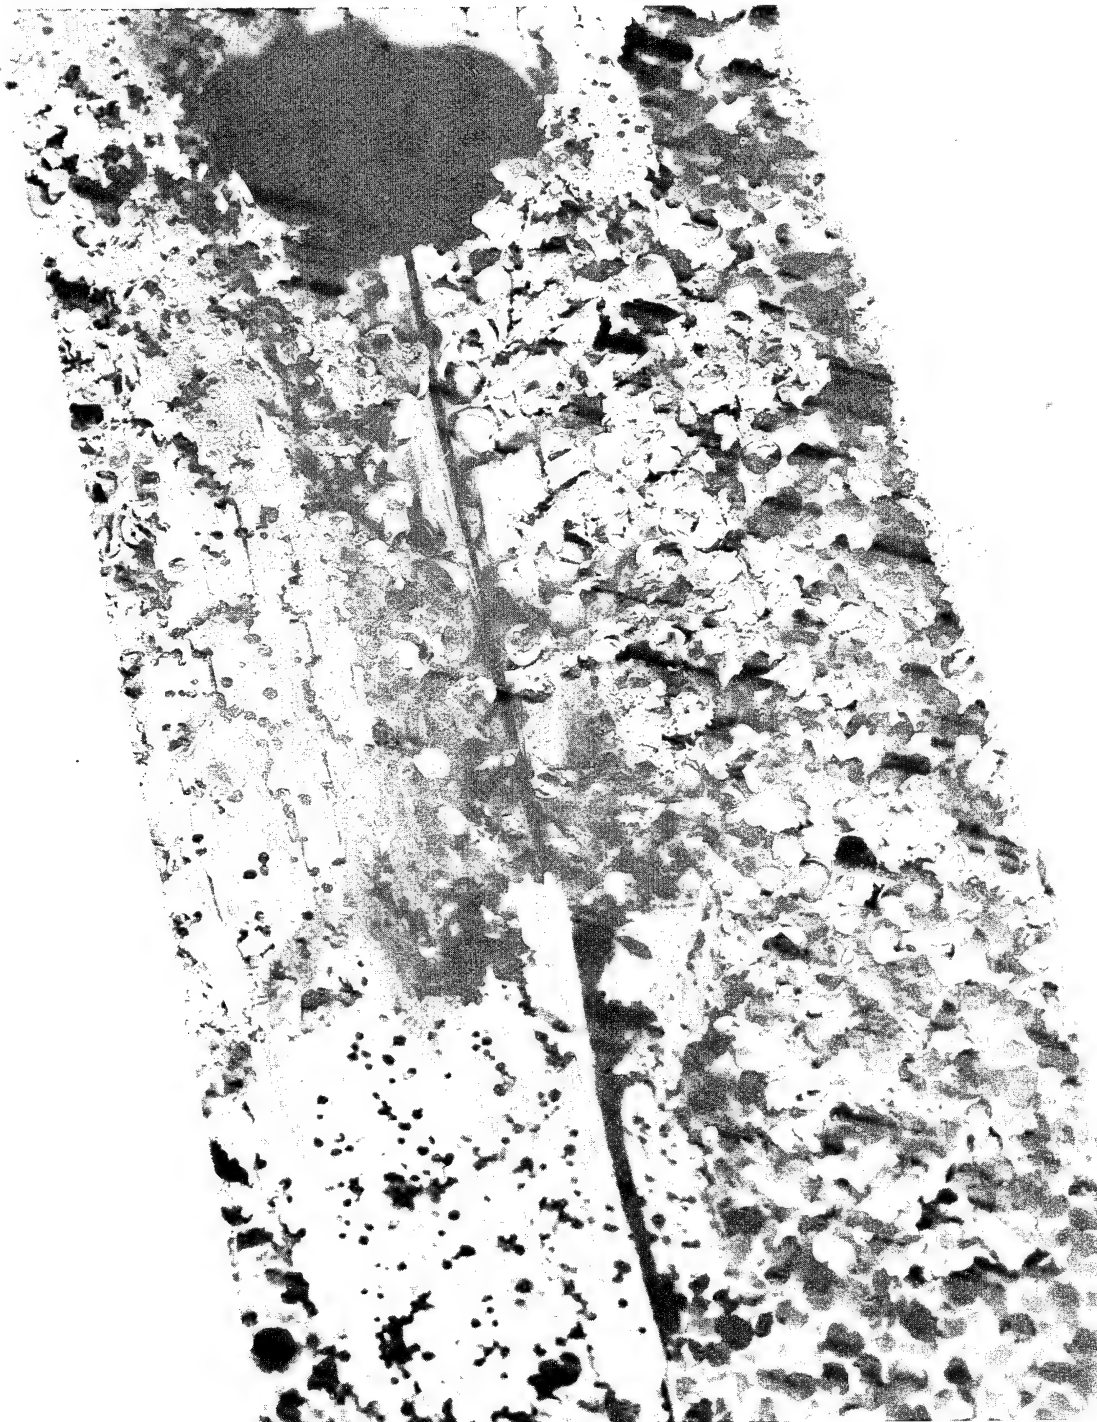
Figure 22. Closeup view of Figure 21 showing borers and borer damage.

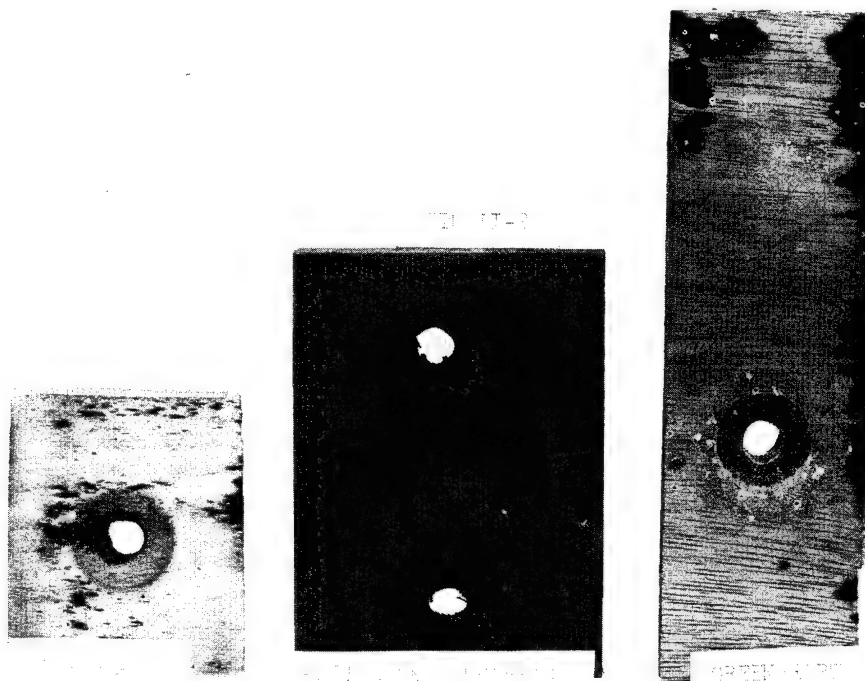
The three tropical wood specimens were attacked by borers (Figure 25). Of these, greenheart sustained the heaviest damage with 14 borers per square inch. The shells of some borers measured about 1/8 inch in diameter, and the borers had penetrated over 1/4 inch into the wood. Afambeau had 7 immature borers per square inch. The borers had penetrated about 1/32 to 1/16 inch. Antidesma was the most resistant of the three tropical wood specimens, with only 2 immature borers per square inch. These borers had penetrated about 1/32 to 1/16 inch. This information was obtained from an examination of a single panel of each of the tropical wood specimens which were exposed about 1 foot above the sediment layer.

Figure 25. Tropical wood specimens (l. to r.) Afambeau, Antidesma pulvinatum, and greenheart.

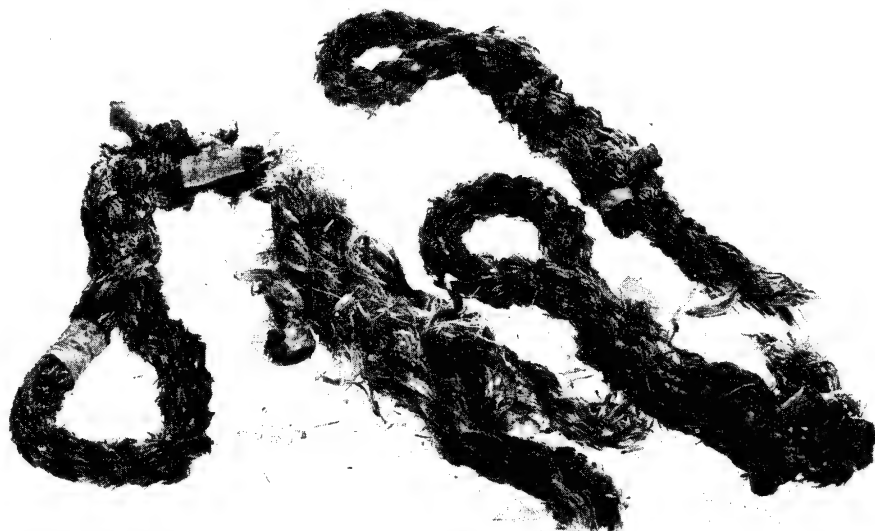
Figure 26. Manila rope specimen completely destroyed by the combined action of borers and microorganisms.

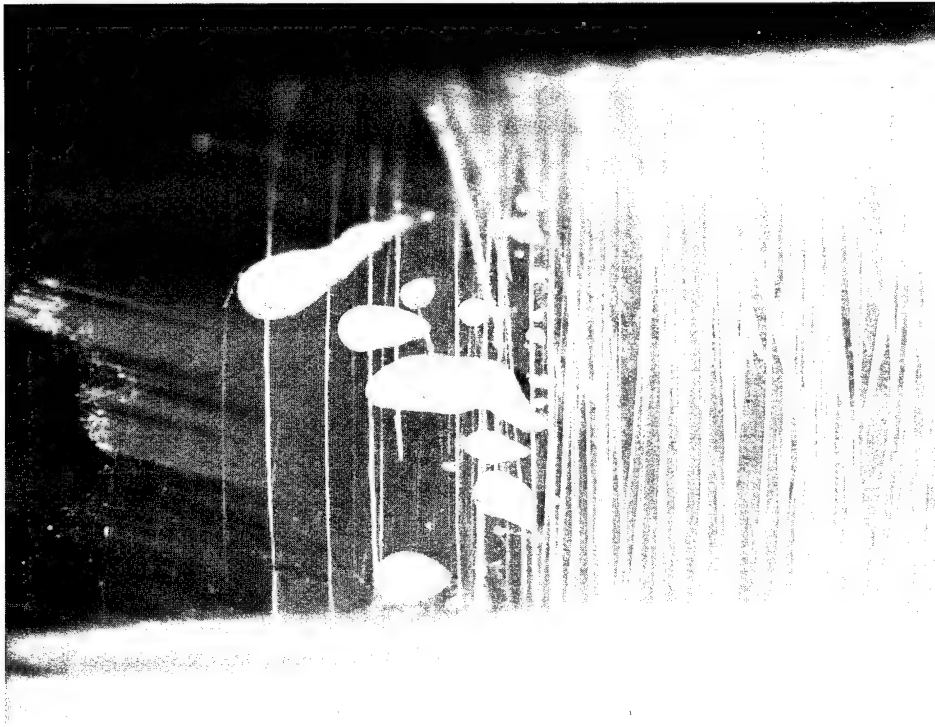
The following plastic sheet, rods, and vinyl tubes were damaged by borers under the wood bait piece: delrin, nylon, phenolic laminates, polycarbonate, Teflon, cellulose acetate, extruded acrylic, polystyrene, and vinyl tubes (NCEL Nos. 424 and 425). Polyvinyl chloride pipe (unplasticized), polyethylene, cast acrylic, and a vinyl tube (NCEL No. 422) were not damaged by borer activity under the bait piece.

Figure 29. Borer damage on the surface of a cellulose acetate rod under area of wood bait piece.

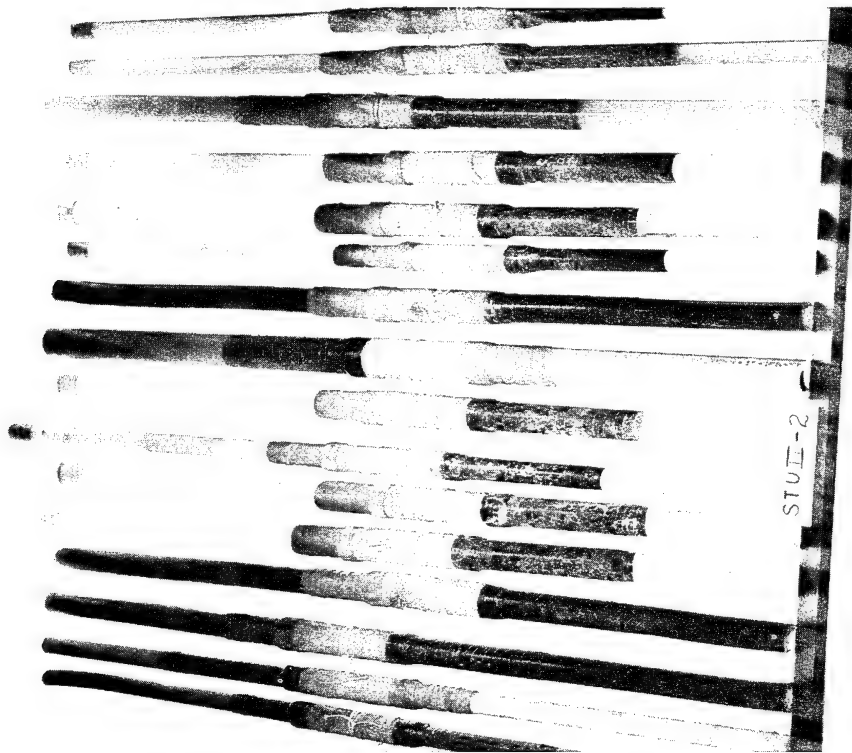
Plastic Specimens. The 3-foot-long plastic rods and vinyl tubes, recovered after 13.4 months on the sea floor in 2,370 feet of water, are shown in Figure 28. There were numerous borer holes, both deep and shallow, underneath the area where the wood bait pieces were fitted over the lower and upper sections of the plastics (Figure 29). Generally, the lower section, exposed about 0.5 to 1 foot above the sediment layer, had more borer holes than the upper sections which were exposed about 3 feet above the sediment. In other words, the borers were found to be more active near the sediment than 3 feet above the sediment layer.

Figure 28. Various types of plastic rods, tubes, pipe, and a rubber vacuum hose with wrappings.

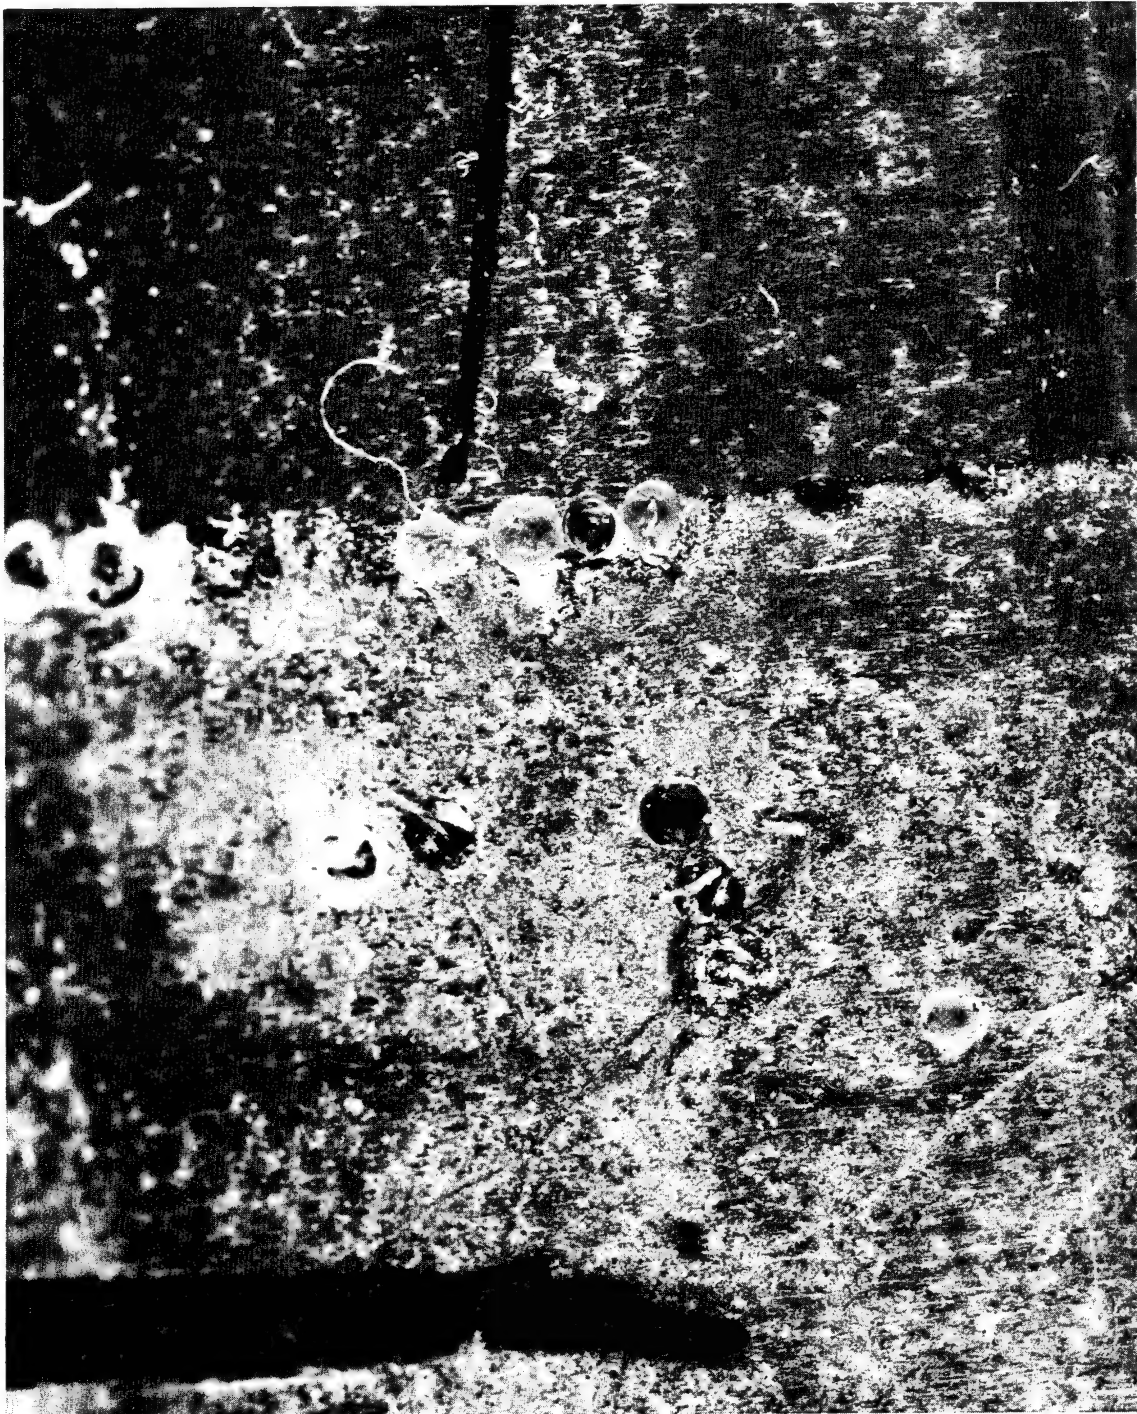
Figure 30. Photomicrograph of borer damage on the surface of a polystyrene plastic rod. The 1/32-inch-diameter borers are visible in holes.

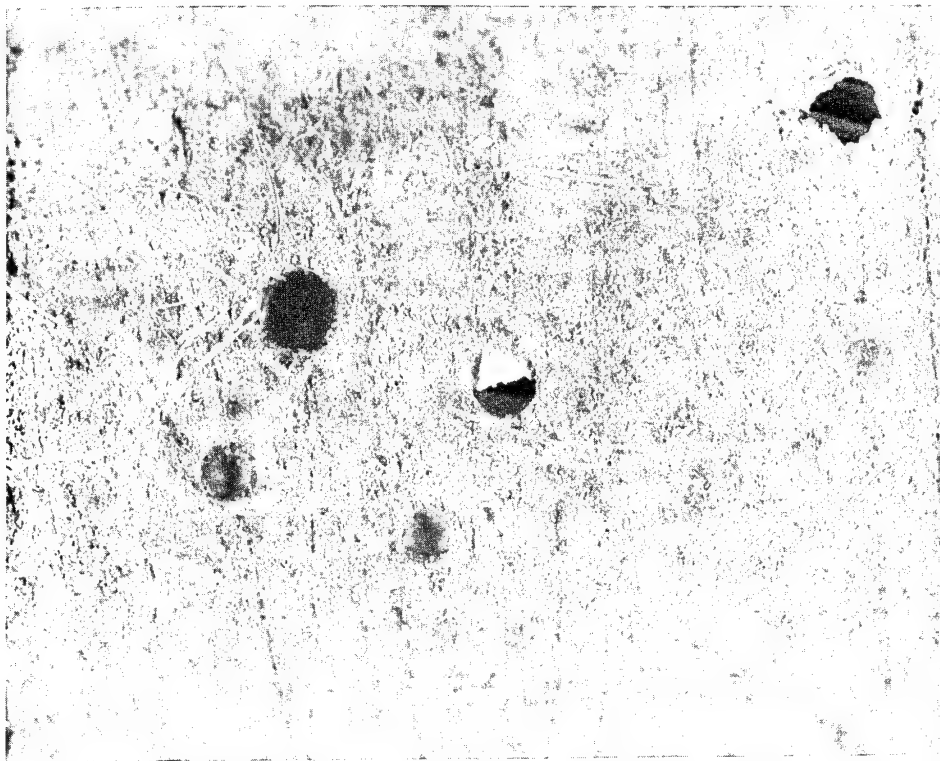
Figure 32. Photomicrograph of borer damage on the surface of a phenolic laminated plastic rod. A 1/16-inch-diameter borer is visible in a hole.

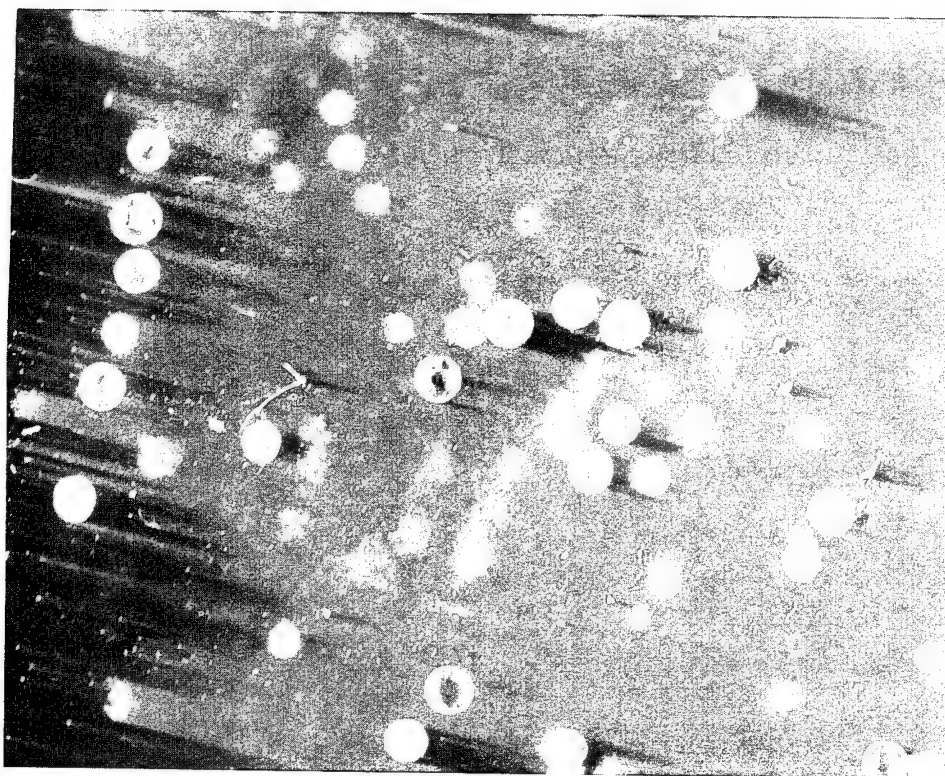
Figure 33. Photomicrograph of borer damage on surface of a vinyl tube. Some of the borer holes are about $1/32$ inch in diameter and about $1/32$ inch deep.

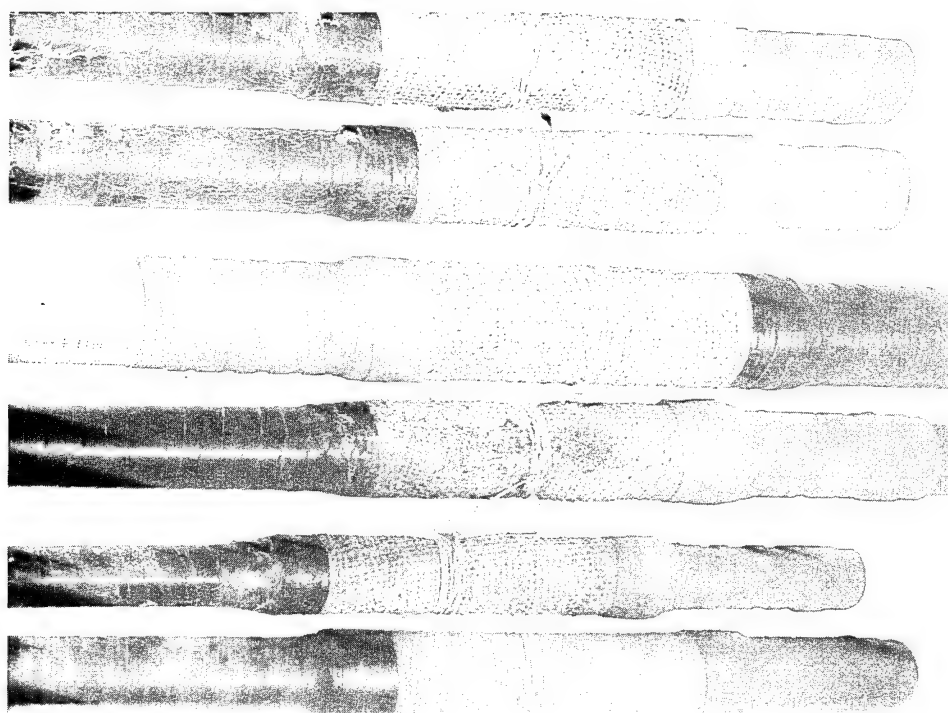
Wrappings Around Plastics. The burlap wrappings were moderately deteriorated by microbial activity, and the material could easily be torn apart by hand. The rubber electrical tape wrappings were not affected by marine organisms, although there was a light hydroid growth on the rubber material. Slight cracks were present in the rubber, and these were probably produced by the effects of the deep sea environment. The plastic tape wrappings were not affected by marine borers; however, there was some hydroid growth on them (Figure 34).

Figure 34. Rubber tape, burlap (jute), and plastic tape wrappings over plastic rods and pipe.

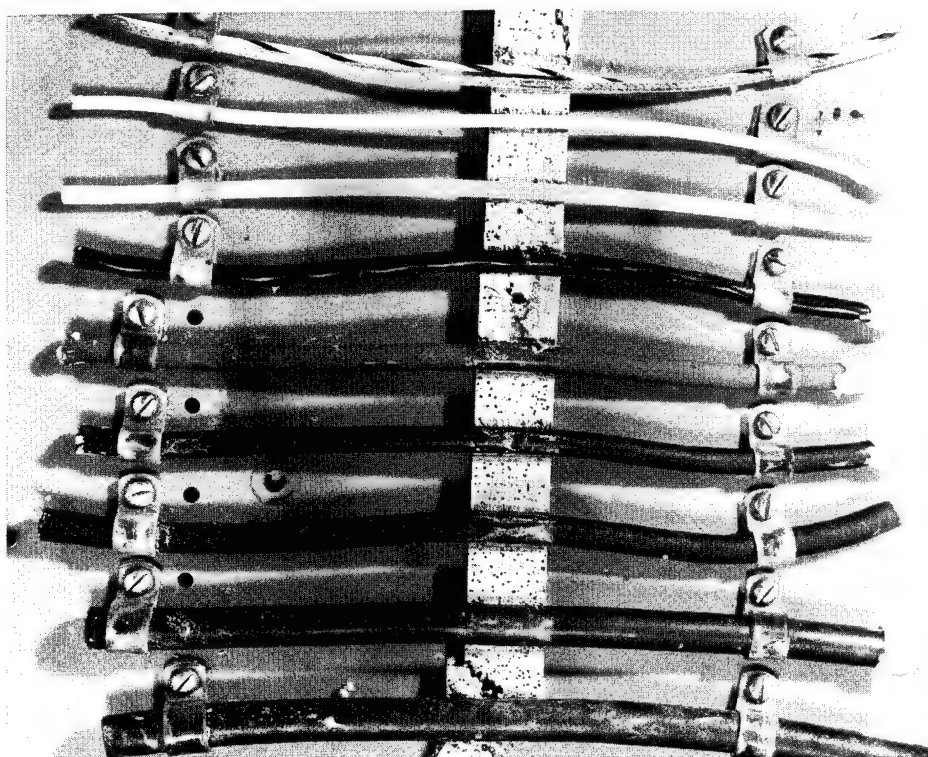
The wood bait pieces were riddled by the borers. However, only silicone rubber insulation and polyethylene insulation were damaged by borer activity under the bait piece exposed near the sediment, and that damage was slight. The other insulations, such as butyl rubber, neoprene rubber, natural rubber, polyvinyl chloride, nylon, fluorinated ethylene propylene (FEP) and Teflon were unaffected by animal activity or by the deep ocean environment (Figure 35).

Figure 35. Single and multiconductor electrical cable insulations in contact with wood bait piece.

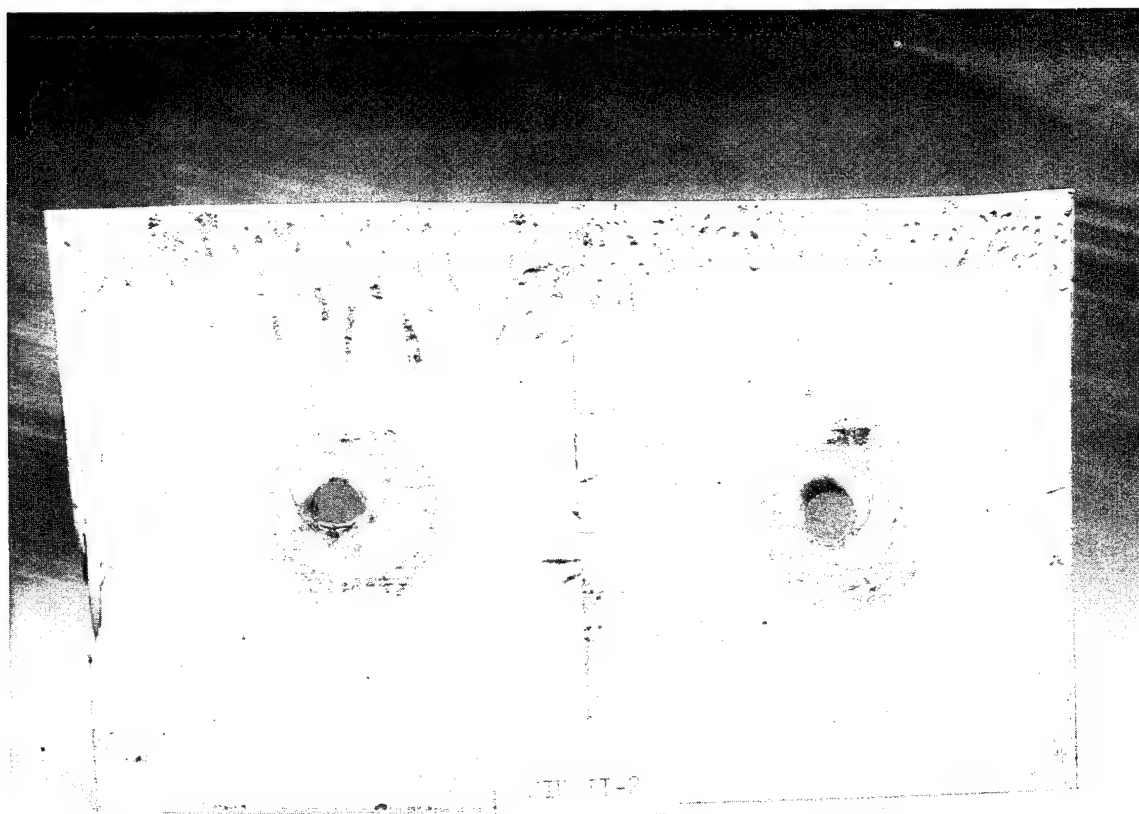
Plastic Sheet. A 0.020x4x4-inch white, high-impact styrene sheet which was used as a spacer between the large wood bait piece and the metal bio-rack was damaged by borers (Figure 37).

Figure 37. Borer damage to 20-mil-thick high-impact styrene sheets which were in contact with wood bait piece.

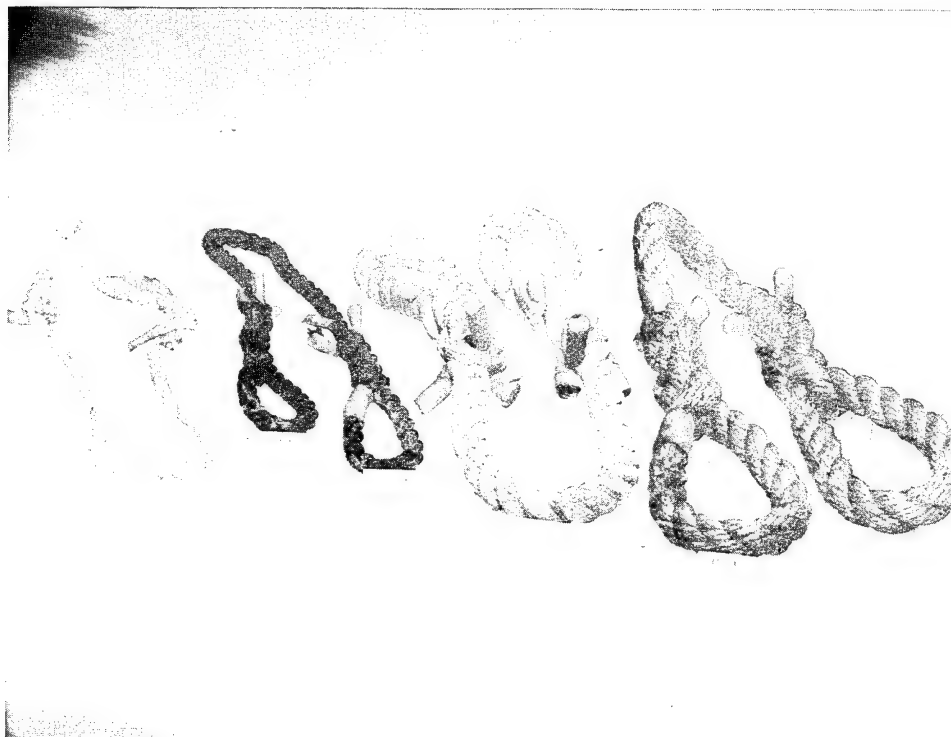
Figure 42. Rope specimens which were placed inside a plastic test chamber.

Generally, the materials placed in the plastic tube were not deteriorated as severely as those materials exposed outside the tube (Figure 42). The fir panel was moderately attacked by borers, with some borers measuring about 1/4 inch in diameter. The fibers of cotton and manila rope specimens were slightly deteriorated by micro-organisms. Borers were not found in manila rope specimens. The synthetic rope specimens were in excellent condition. The various electrical cable insulations (15 mils thick) on No. 16 wire were not affected. However, a large section of the white polyvinyl chloride insulation had turned black after being exposed to the hydrogen sulfide in the mud (Figure 43). This change occurred probably because there may have been small quantities of lead in the PVC insulation, and this lead had reacted with hydrogen sulfide to form lead sulfide, which is black. Small test strips of white polyvinyl chloride materials such as this could probably be used to detect the presence of hydrogen sulfide in an anaerobic environment, especially in areas where conventional testing devices cannot be placed or used for detecting hydrogen sulfide.
